**SITE ASSESSMENT REPORT
FOR
FROST MANUFACTURING COMPANY
KENOSHA, KENOSHA COUNTY, WISCONSIN
TDD: S05-9606-022
PAN: 6N2201SI**

January 27, 1997

**UNITED STATES ENVIRONMENTAL PROTECTION AGENCY
Emergency and Enforcement Response Branch
77 West Jackson Boulevard
Chicago, Illinois 60604**

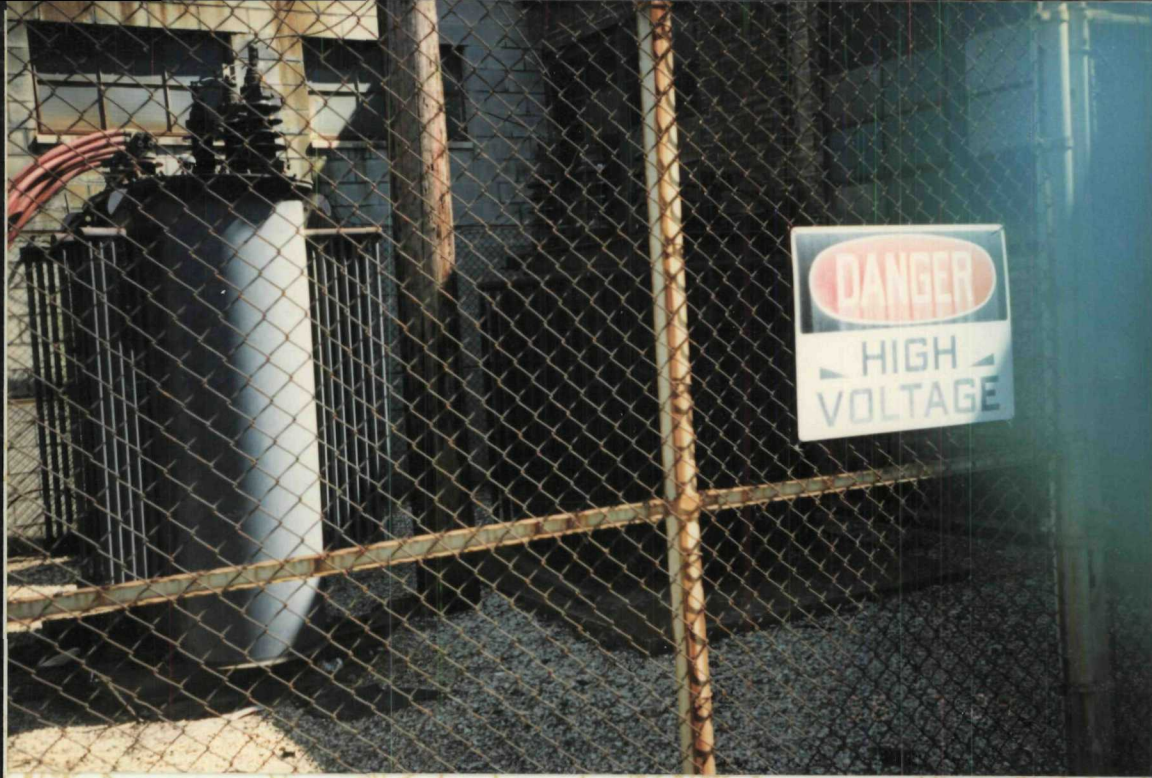
Site: Frost Manufacturing Company **Date:** 7-24-96 **Direction:** West
Camera: Olympus Infinity 35mm **Photographer:** J. Nordine
Subject: Two large transformers located on the east side of the main plant building.

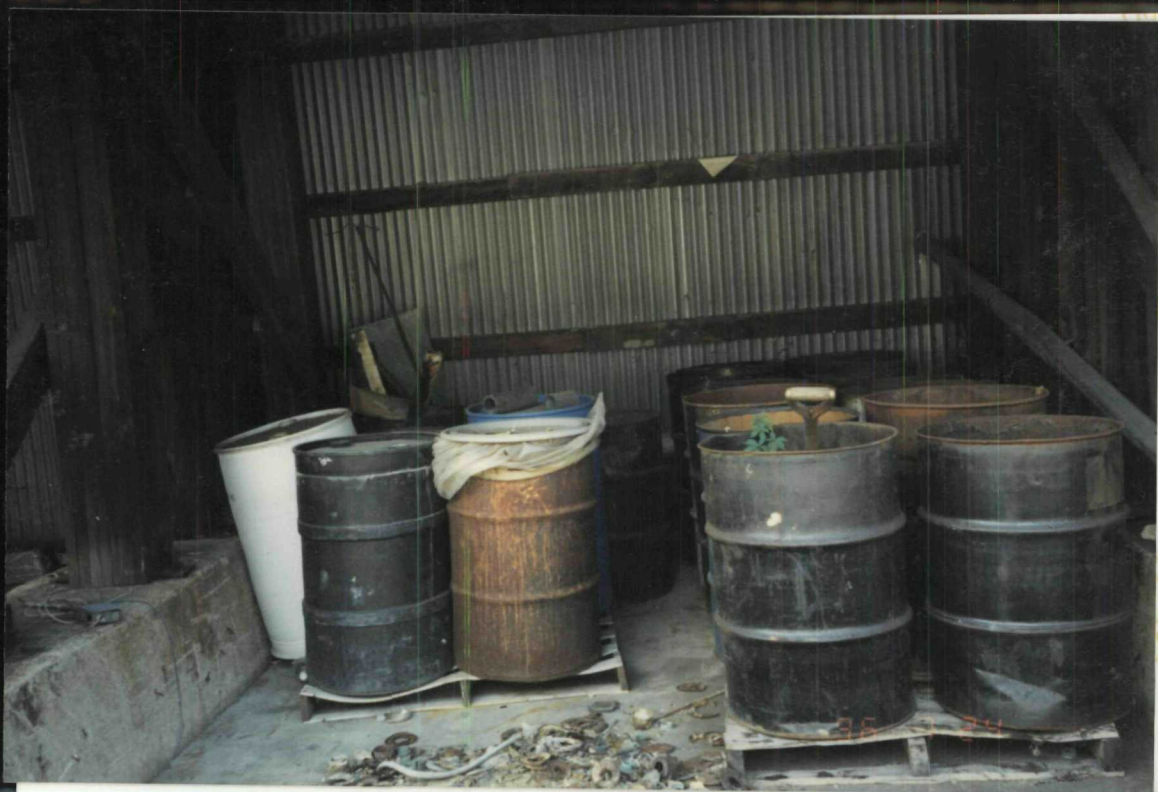
Site: Frost Manufacturing Company **Date:** 7-24-96 **Direction:** East
Camera: Olympus Infinity 35mm **Photographer:** J. Nordine
Subject: Eighteen 55-gallon drums of unknown contents located in a shed east of the main plant building.

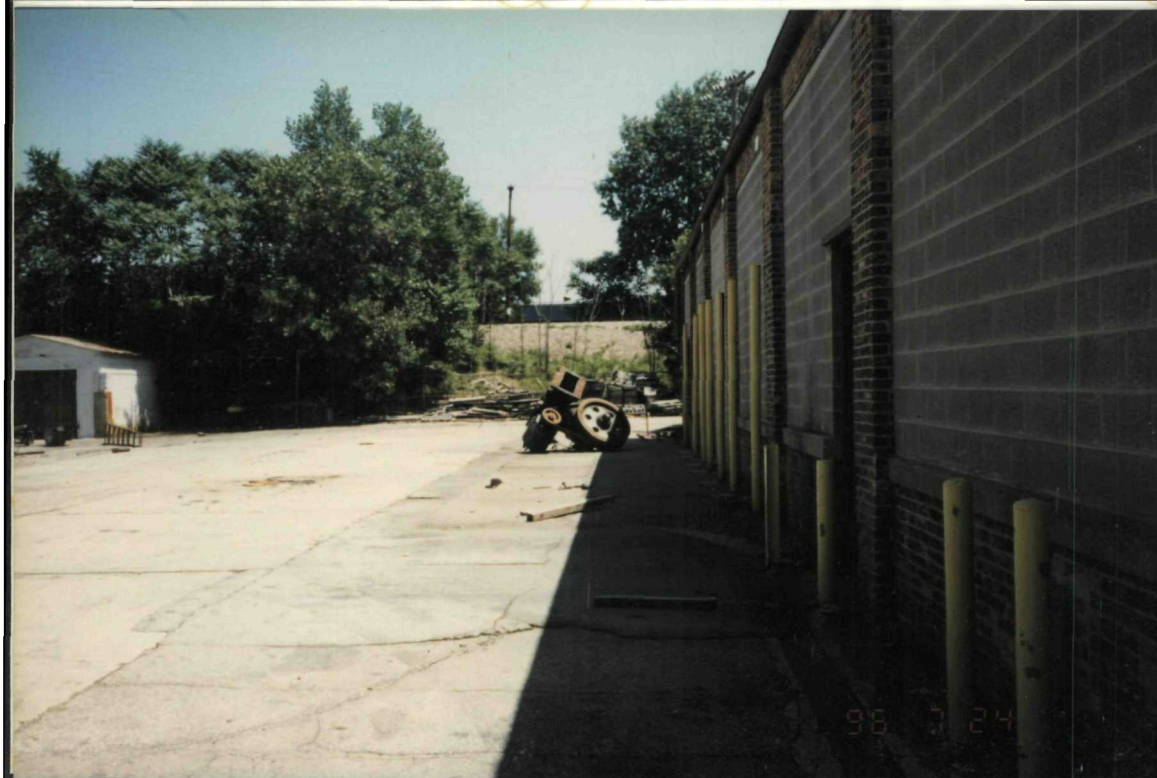
Site: Frost Manufacturing Company **Date:** 7-24-96 **Direction:** East
Camera: Olympus Infinity 35mm **Photographer:** J. Nordine
Subject: The north side of the main plant building.

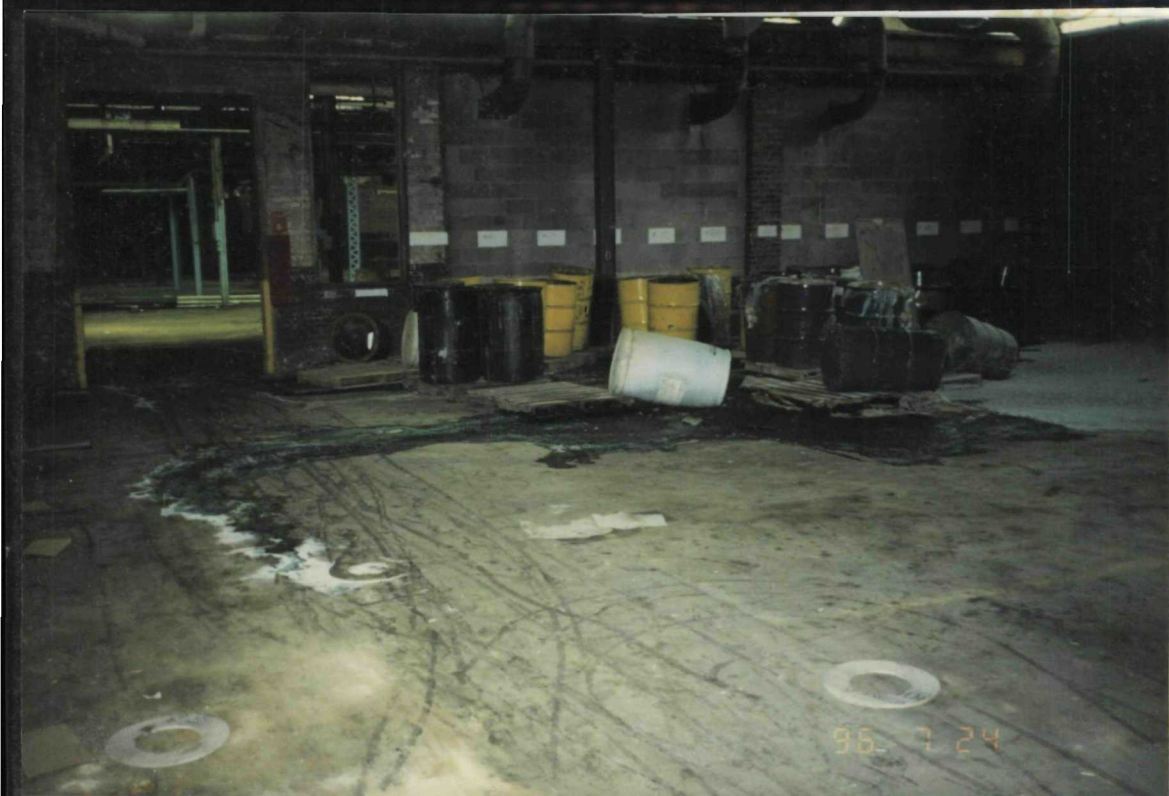
Site: Frost Manufacturing Company **Date:** 7-24-96 **Direction:** Unknown
Camera: Olympus Infinity 35mm **Photographer:** J. Nordine
Subject: Thirty 55-gallon drums located in the main plant. Three of the drums had been tipped over by vandals, spilling the drums' contents.

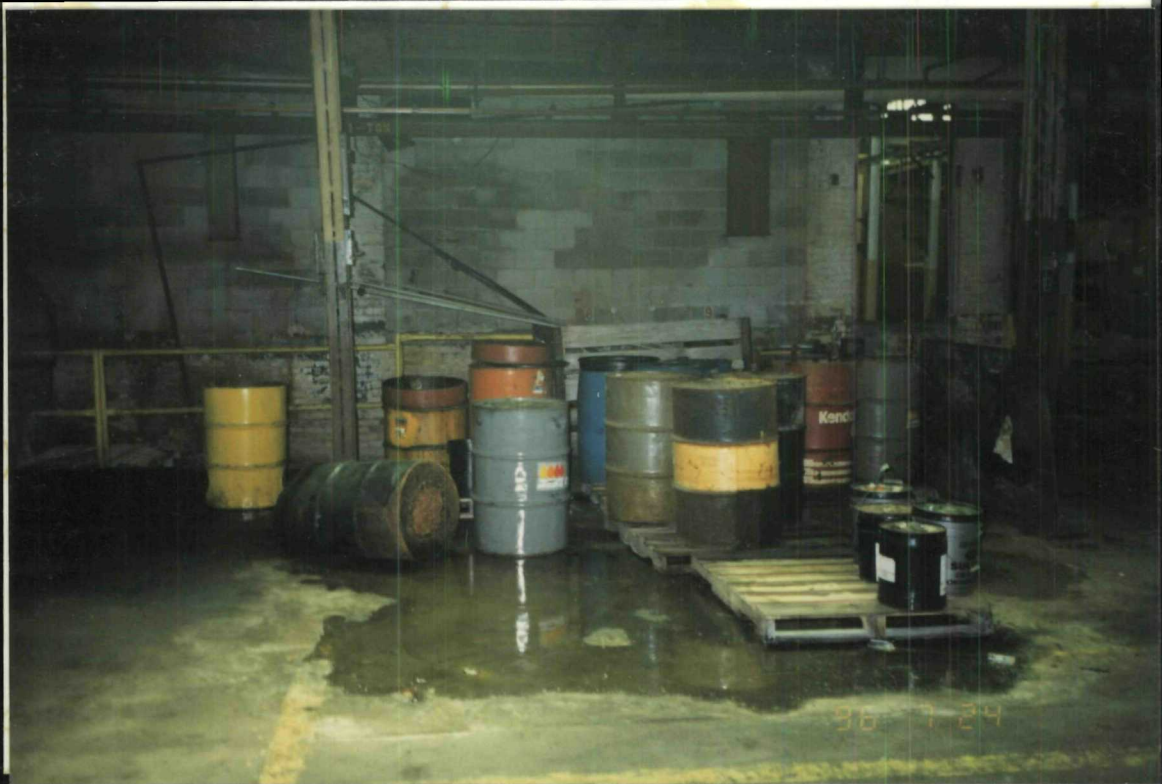
Subject: Seventeen 55-gallon drums and four 5-gallon pails located in the old water treatment area of the main plant building.

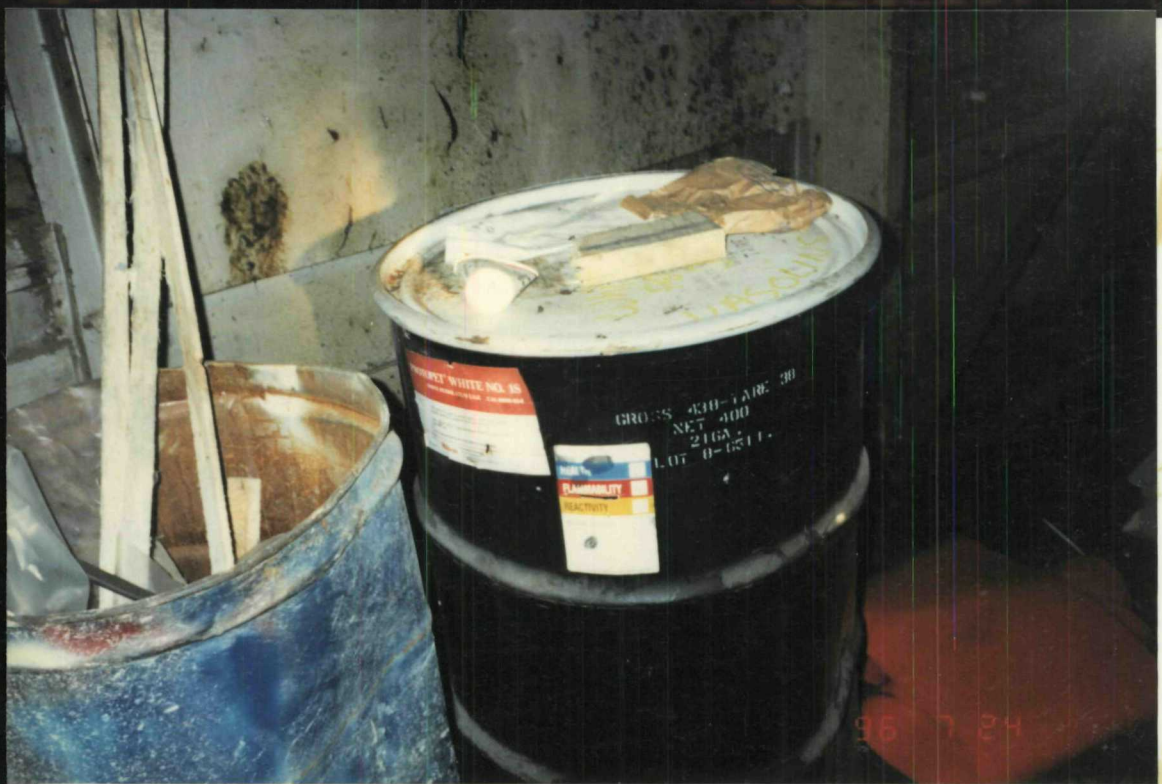
Subject: 55-gallon drum labeled "Protopet White No. 1S, White Petroleum USP Case# 8009-03-8."

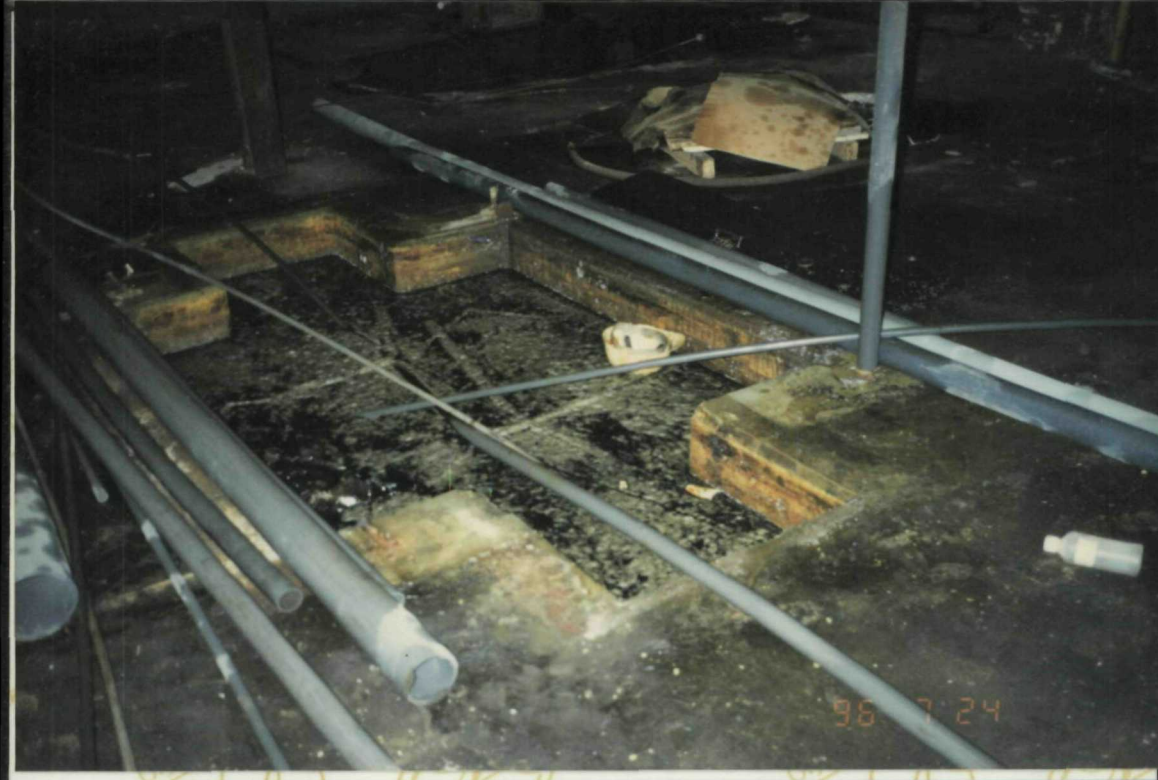
Site: Frost Manufacturing Company **Date:** 7-24-96 **Direction:** Unknown
Camera: Olympus Infinity 35mm **Photographer:** J. Nordine
Subject: One of several pits filled with unknown liquids in the main plant.

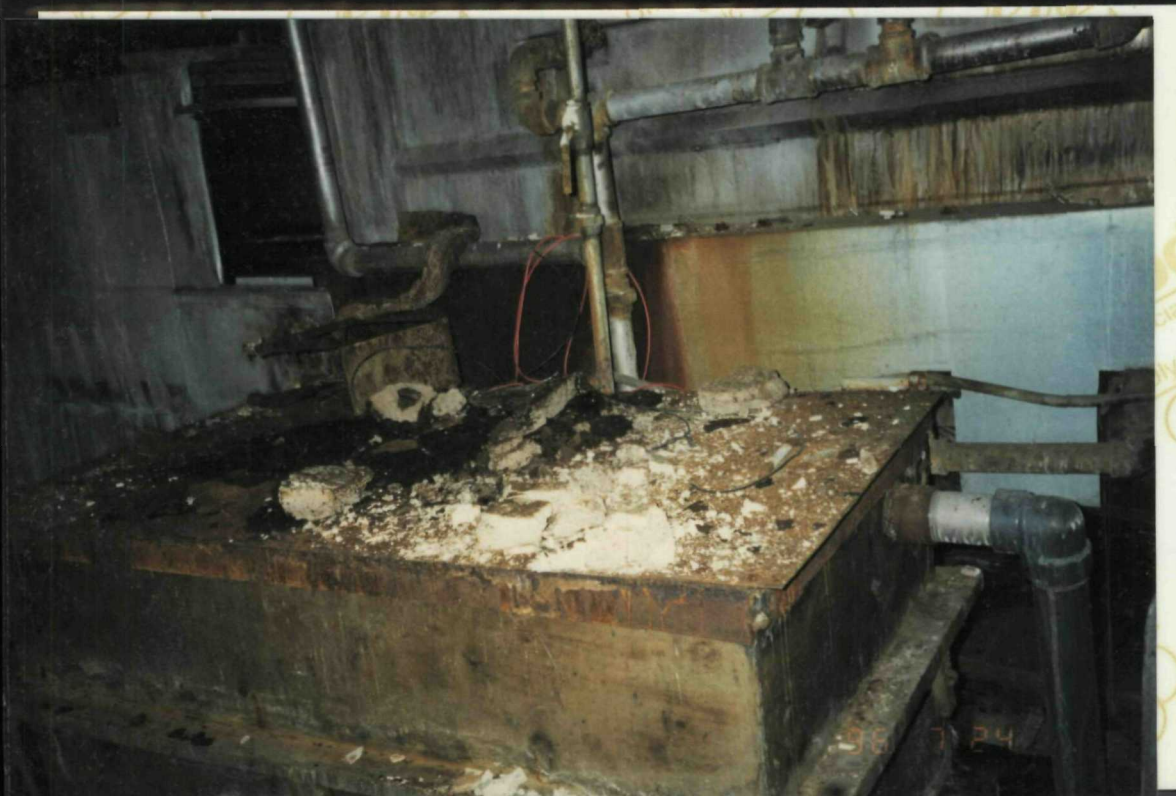
Site: Frost Manufacturing Company **Date:** 7-24-96 **Direction:** East
Camera: Olympus Infinity 35mm **Photographer:** J. Nordine
Subject: Friable material fallen from the ceiling located near the annealing furnace. Sample A1 was collected from this material.

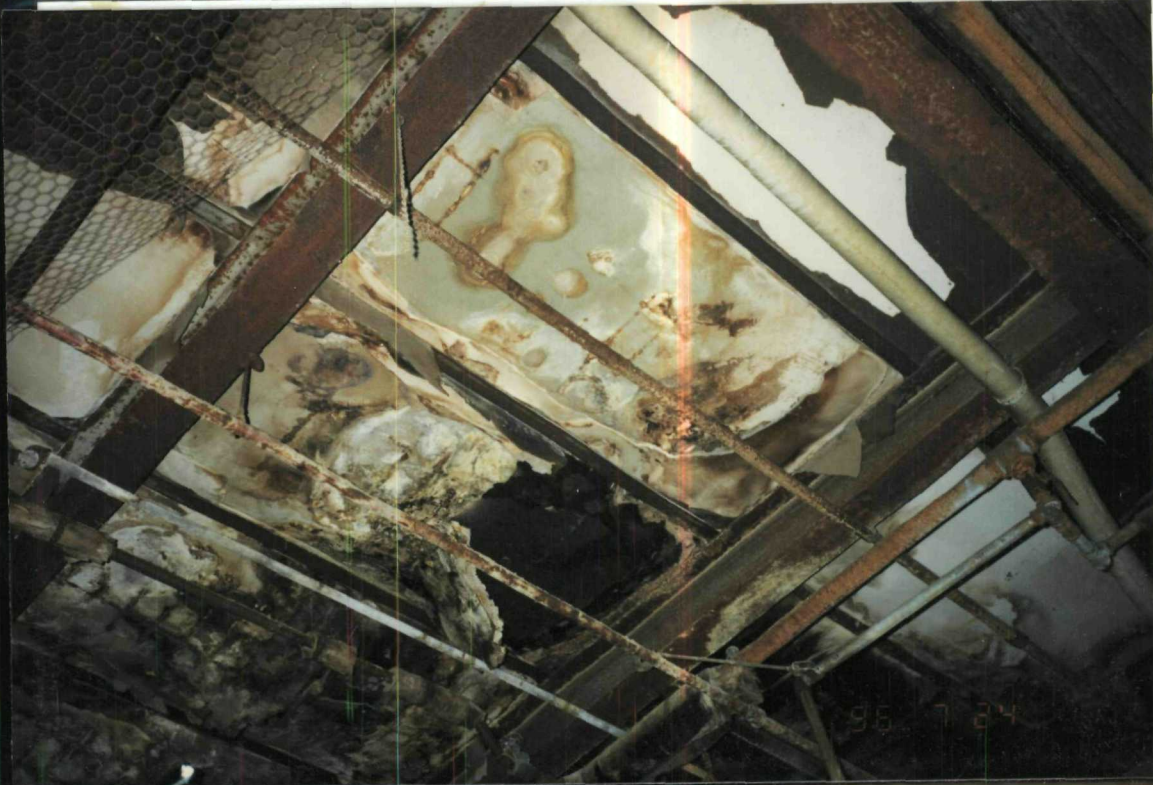
Site: Frost Manufacturing Company **Date:** 7-24-96 **Direction:** Up
Camera: Olympus Infinity 35mm **Photographer:** J. Nordine
Subject: Friable ceiling material located above the annealing furnace.

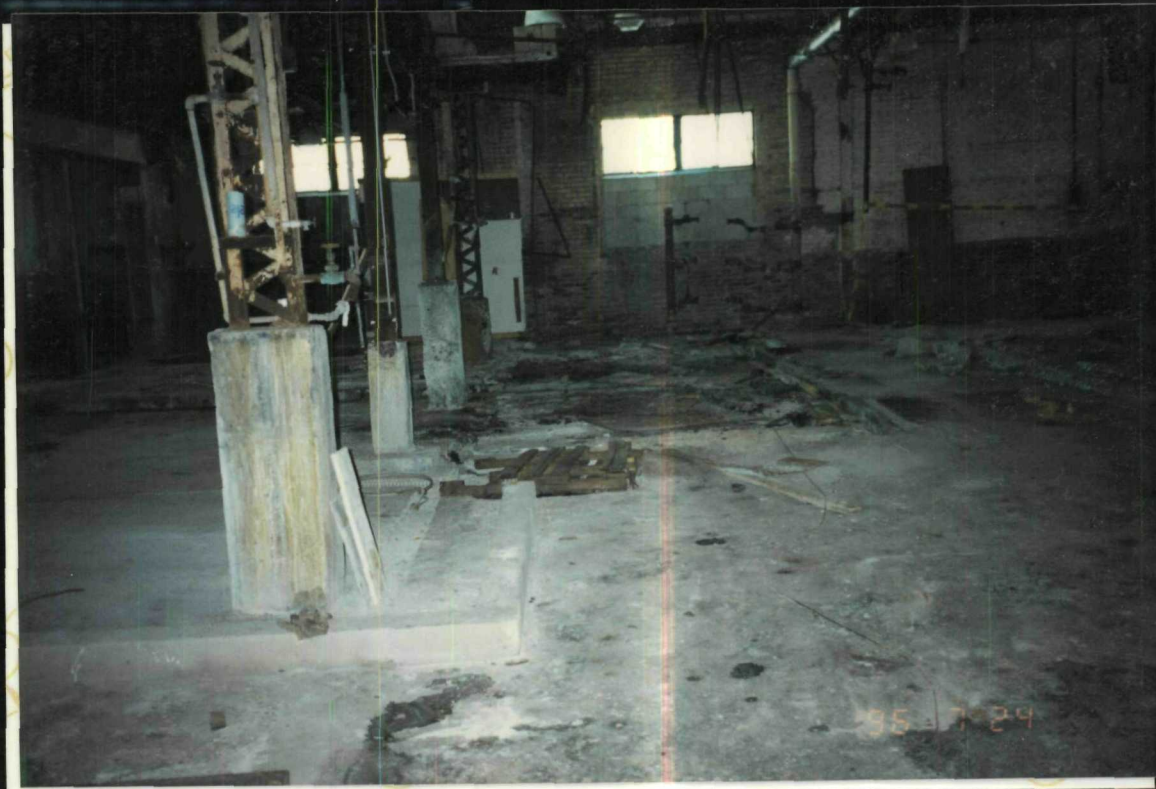
Site: Frost Manufacturing Company **Date:** 7-24-96 **Direction:** South
Camera: Olympus Infinity 35mm **Photographer:** J. Nordine
Subject: View of the south side of the plating area.

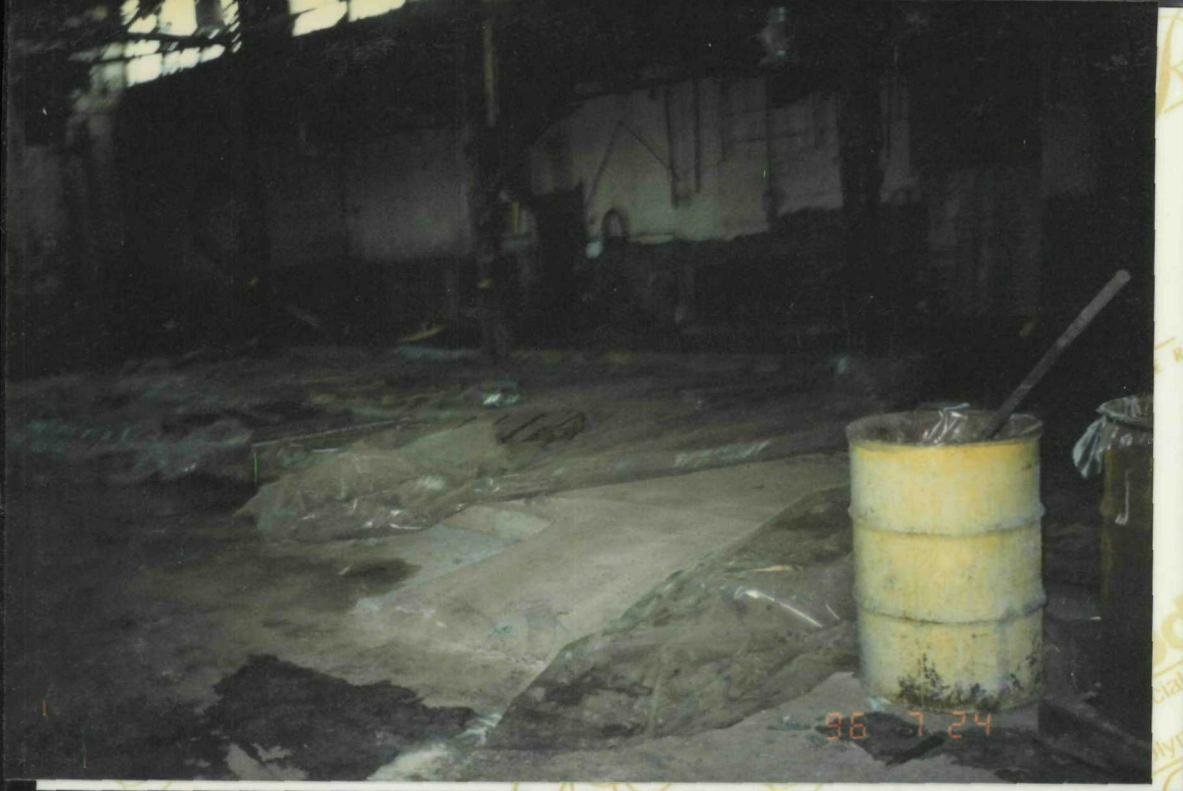
Site: Frost Manufacturing Company **Date:** 7-24-96 **Direction:** North
Camera: Olympus Infinity 35mm **Photographer:** J. Nordine
Subject: View of the north side of the plating area.

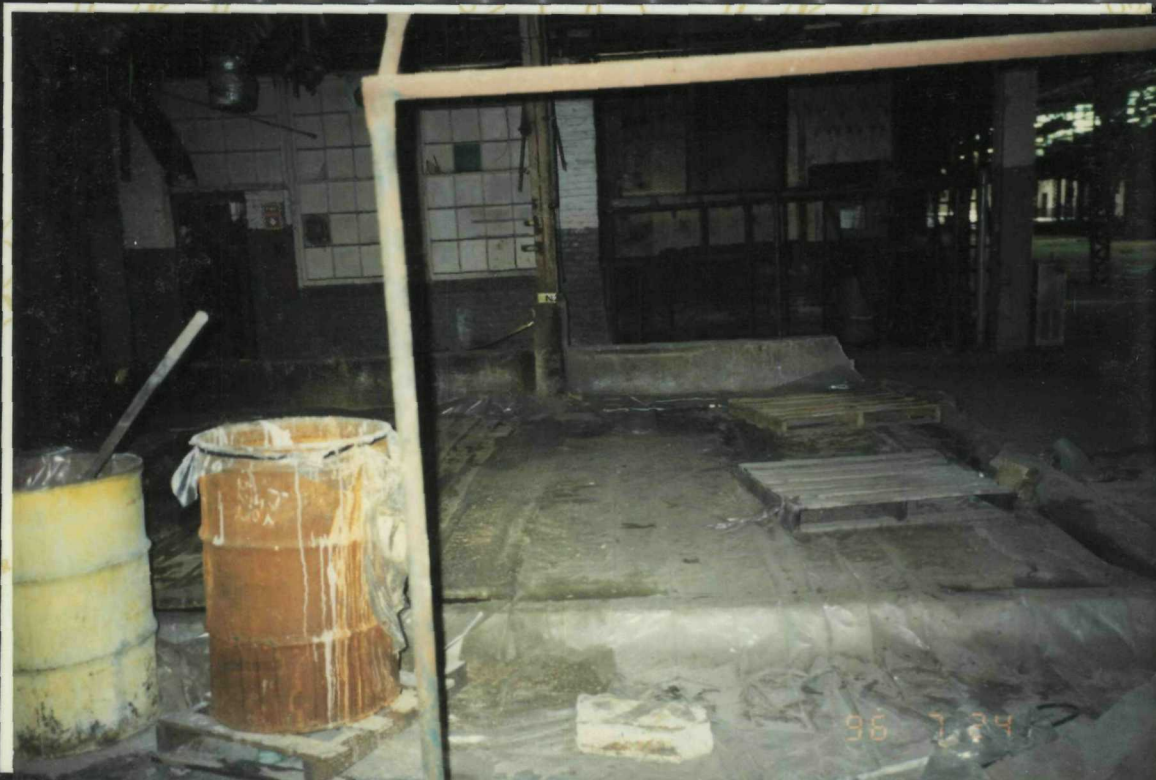
Site: Frost Manufacturing Company **Date:** 7-24-96 **Direction:** North
Camera: Olympus Infinity 35mm **Photographer:** J. Nordine
Subject: View of the northeast side of the plating area.

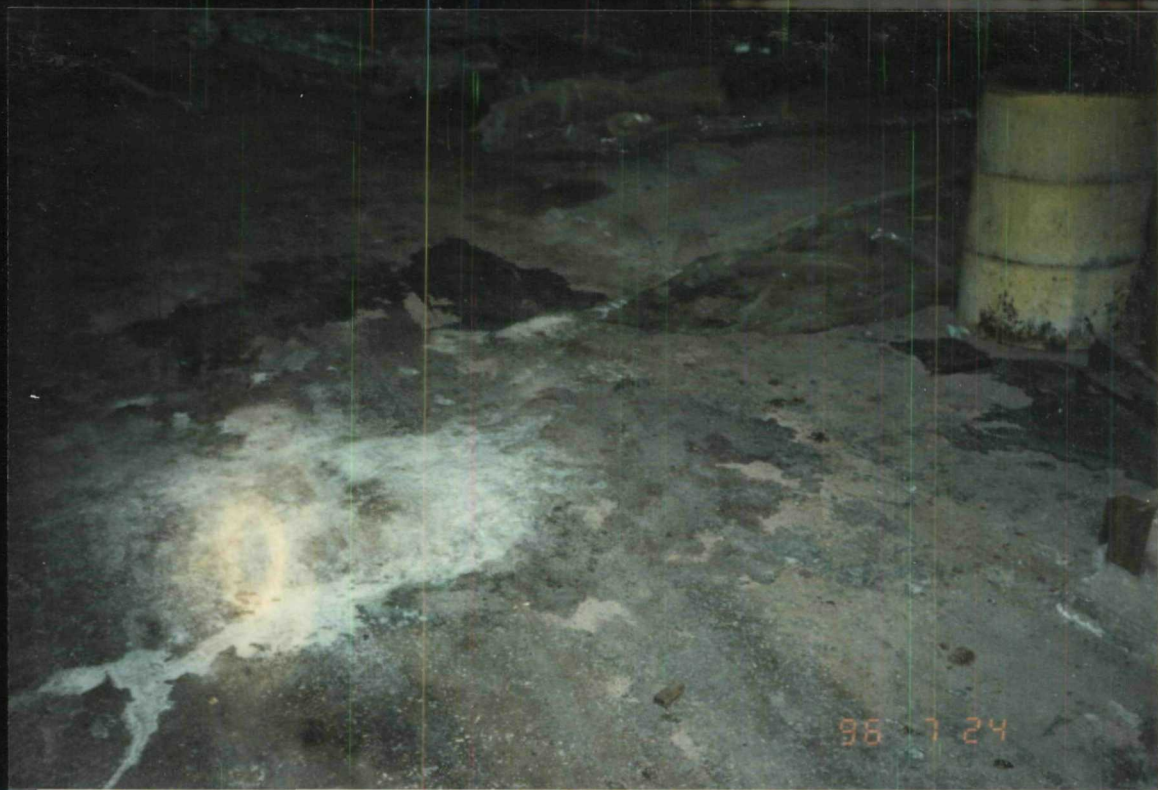
Site: Frost Manufacturing Company **Date:** 7-24-96 **Direction:** Northwest
Camera: Olympus Infinity 35mm **Photographer:** J. Nordine
Subject: White substance that was spilled on the plating room floor.

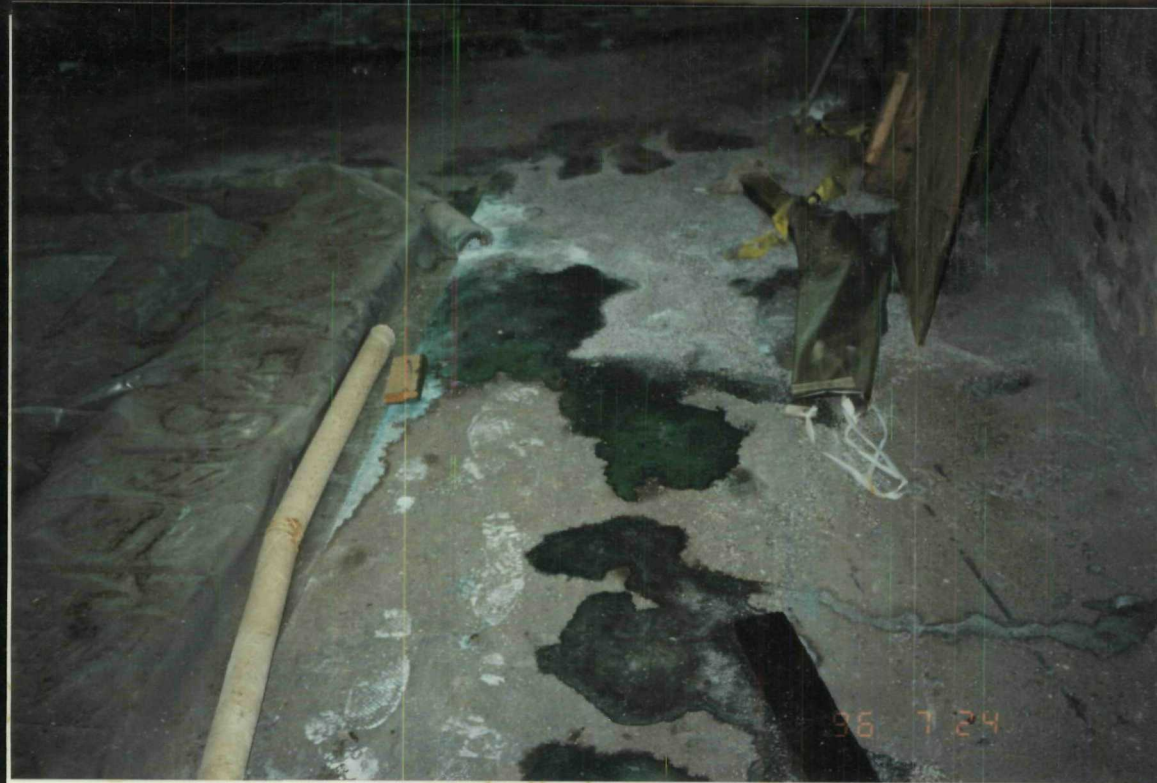
Site: Frost Manufacturing Company **Date:** 7-24-96 **Direction:** West
Camera: Olympus Infinity 35mm **Photographer:** J. Nordine
Subject: Bright green liquid spilled from piping in the plating room.

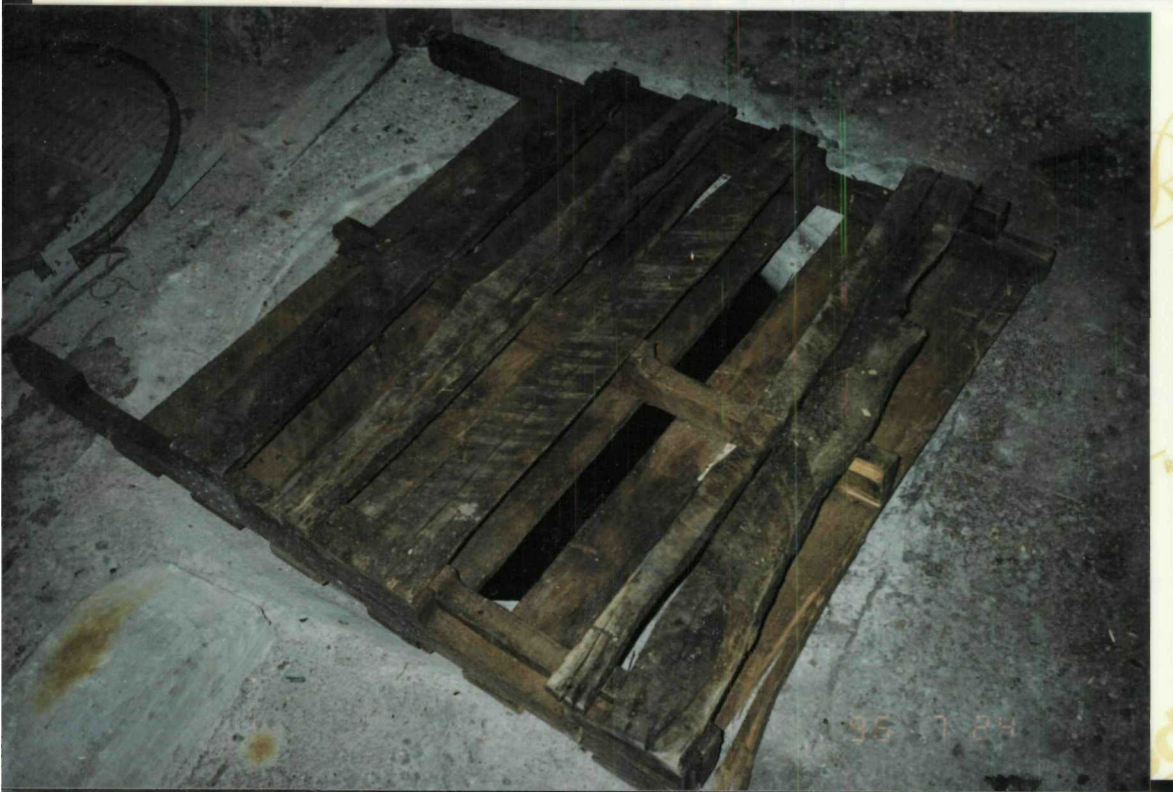
Site: Frost Manufacturing Company **Date:** 7-24-96 **Direction:** Down
Camera: Olympus Infinity 35mm **Photographer:** J. Nordine
Subject: Sump located in the plating room. Sample V2 was collected from the liquid in the sump.

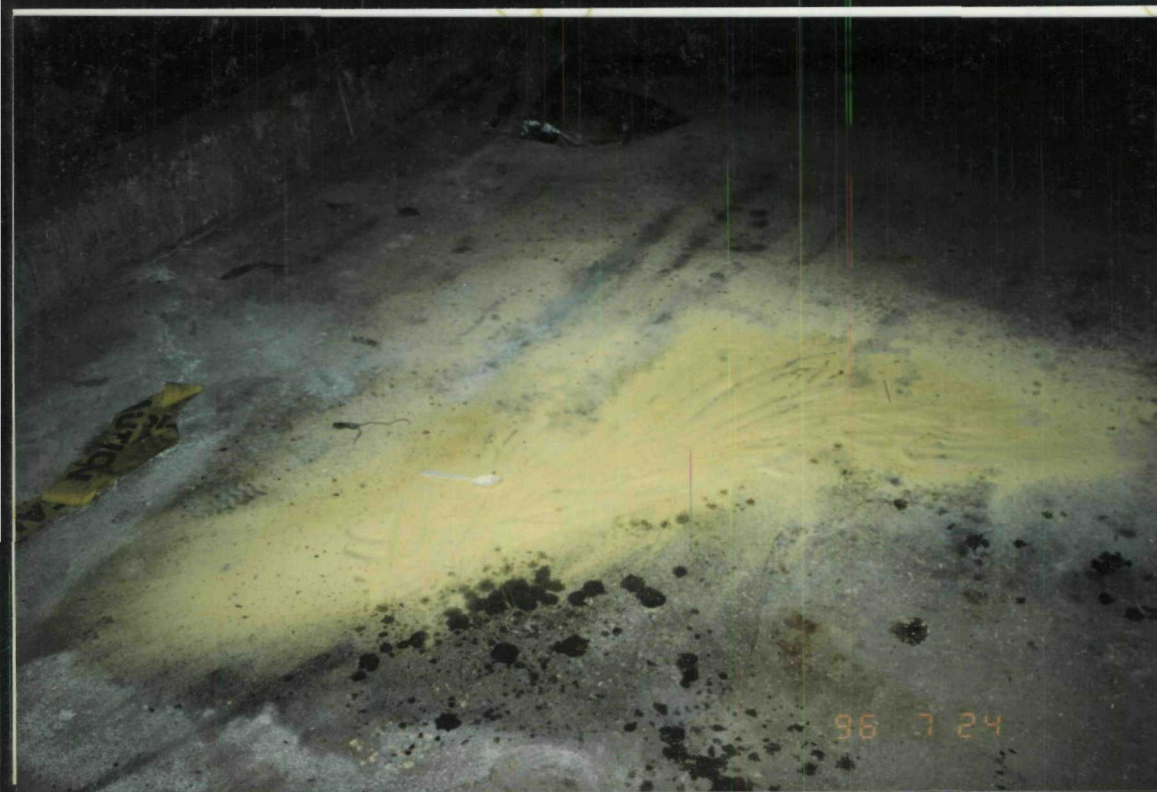
Site: Frost Manufacturing Company **Date:** 7-24-96 **Direction:** North
Camera: Olympus Infinity 35mm **Photographer:** J. Nordine
Subject: Sample S1 collected from a yellow powder that had been spilled near the plating room.

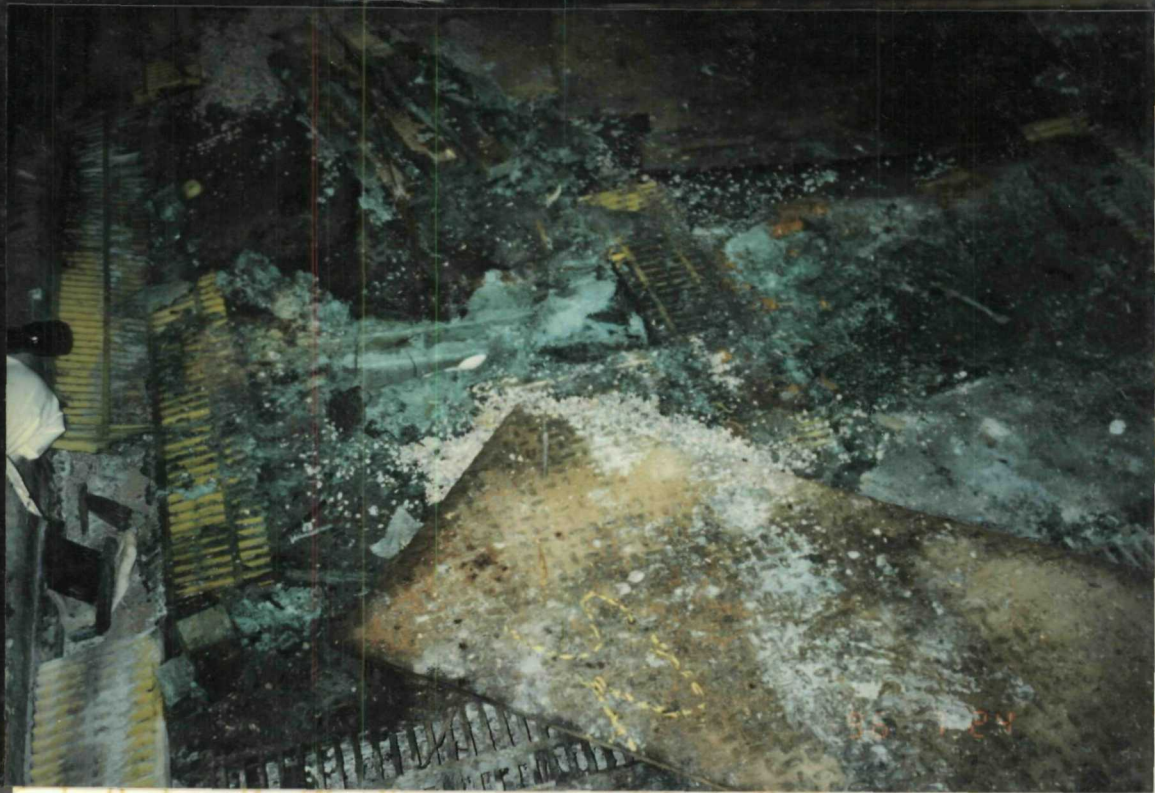
Site: Frost Manufacturing Company **Date:** 7-24-96 **Direction:** ---
Camera: Olympus Infinity 35mm **Photographer:** J. Nordine
Subject: Sample S2 was collected from plating solids from the raceways in the plating room.

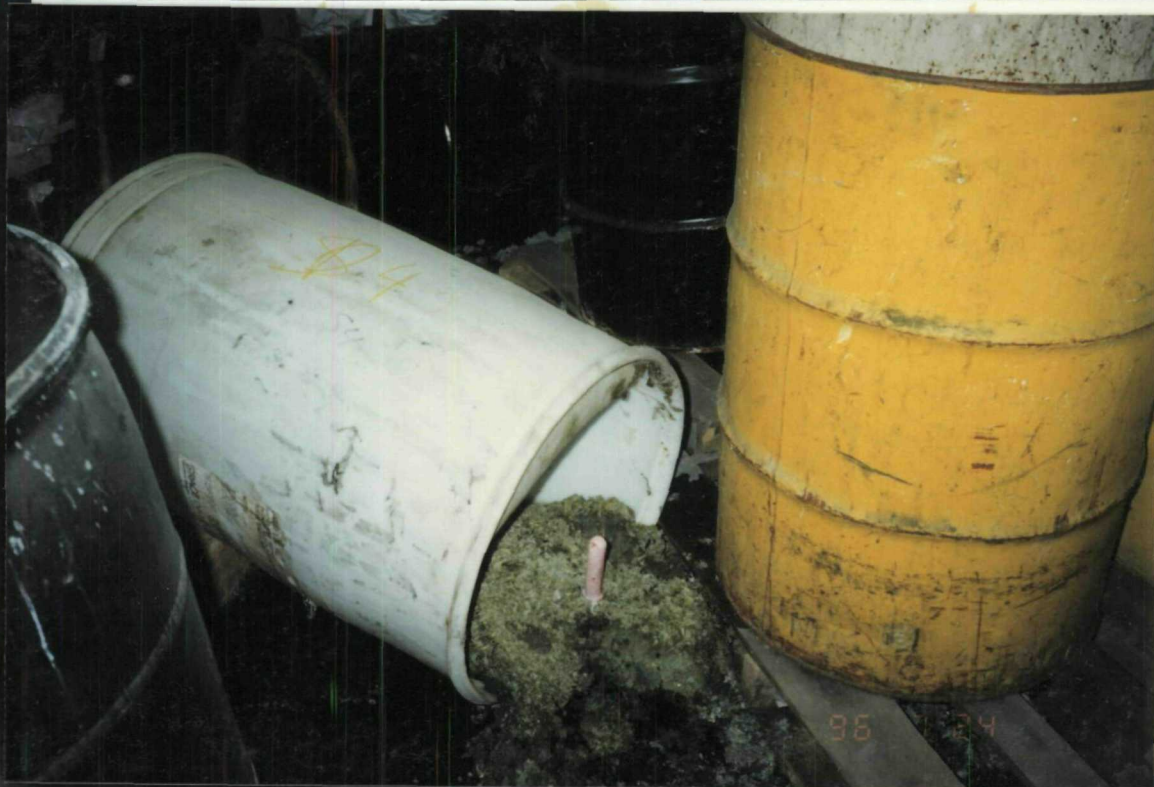
Site: Frost Manufacturing Company **Date:** 7-24-96 **Direction:** ---
Camera: Olympus Infinity 35mm **Photographer:** J. Nordine
Subject: Sample S4 was collected from solids that spilled from a drum.

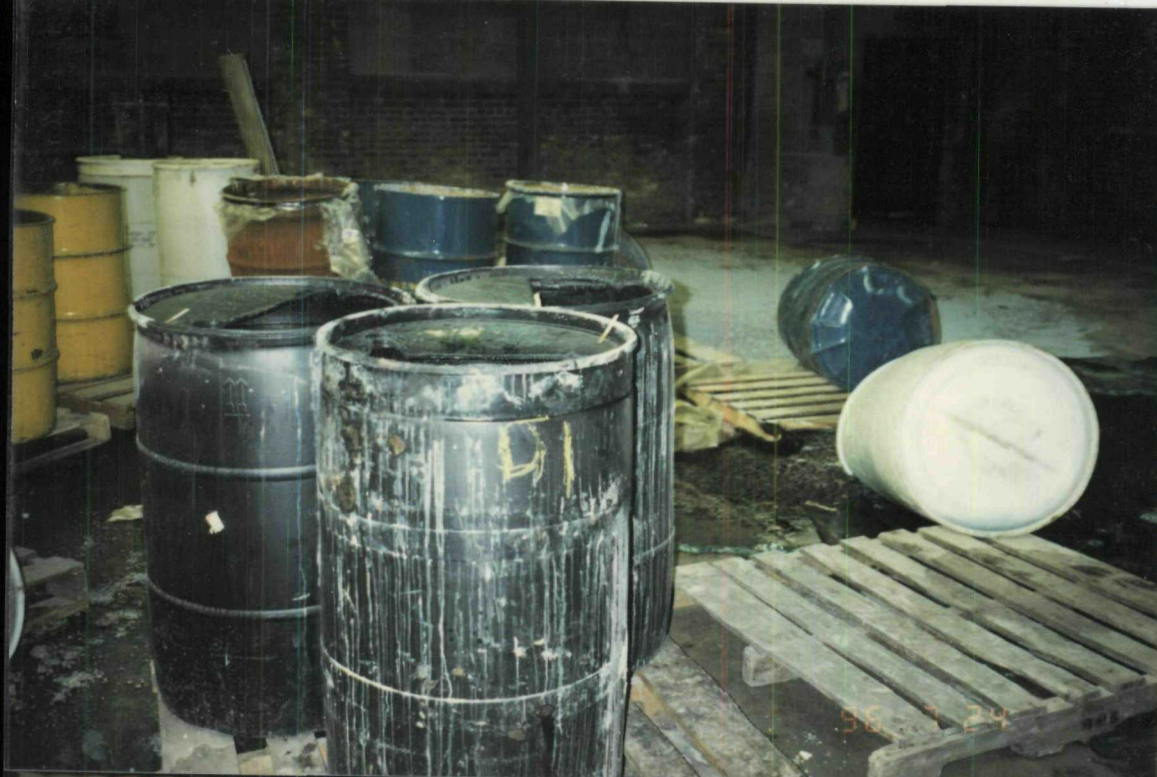
Site: Frost Manufacturing Company **Date:** 7-24-96 **Direction:** ---
Camera: Olympus Infinity 35mm **Photographer:** J. Nordine
Subject: Sample D1 was collected from a liquid in this drum.

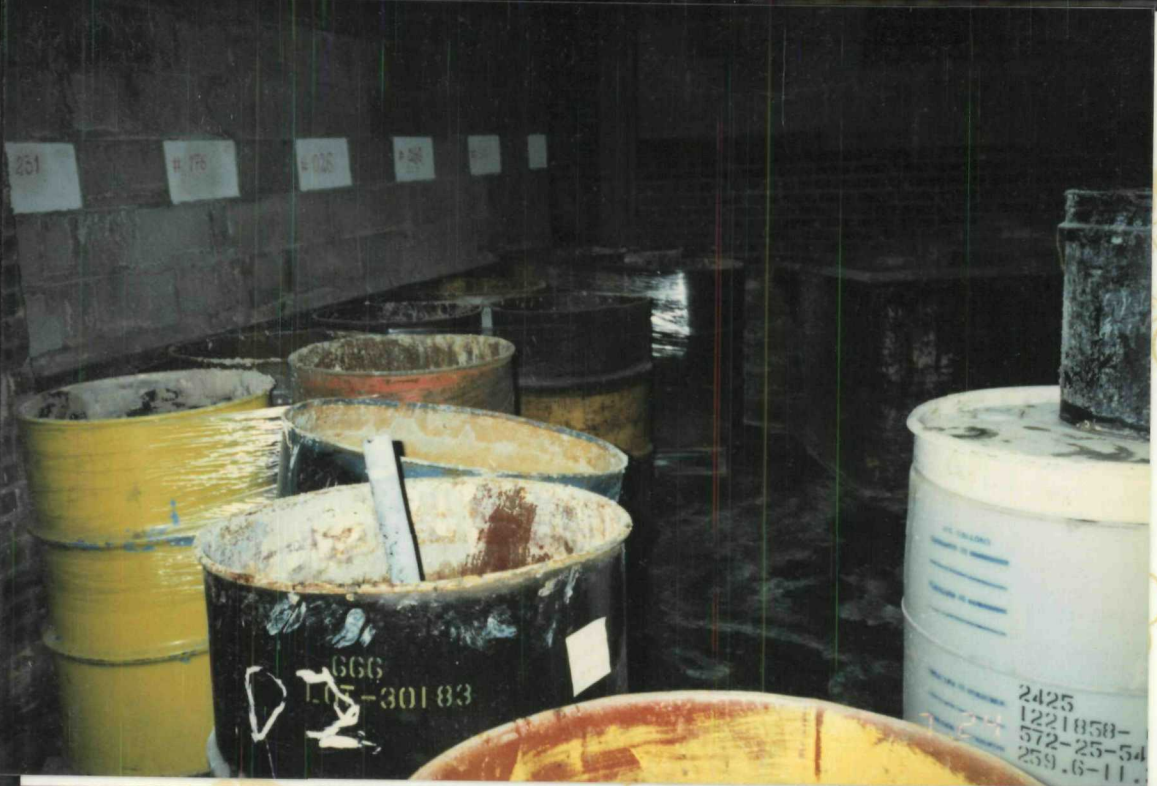
Site: Frost Manufacturing Company **Date:** 7-24-96 **Direction:** ---
Camera: Olympus Infinity 35mm **Photographer:** J. Nordine
Subject: Sample D2 was collected from a liquid from this drum.
